# Manhole Inspection Summary

Manhole # S29K\_\_002MH

Insp Date: **10/27/08 11:38 AM**

**Location** Address: **228 Otterbein St**

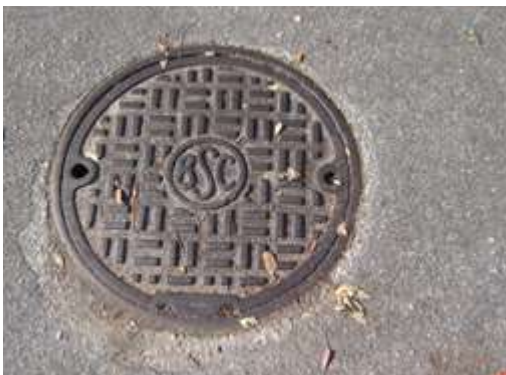
misc-3

mh cover

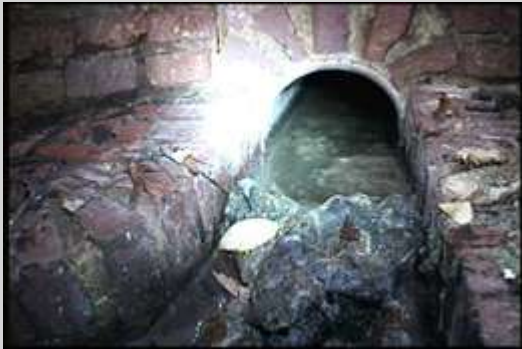
12 O'Clock Outflow

8 in. Circular Gravity Sewer  
Pipe In @ 3 O'Clock

Pipe Height: **8.4** (in.) Rod and Bar (Angled)  
Pipe Material: **PVC** ☐ Pipe Lined  
Invert Depth: **9.05** (ft.) Flow Characteristics: **None**  
Deposits: ☒ None ☐ Mud ☐ ~~Gravy~~ ☐ Debris ☐ Grease  
Silt Depth: **0** (in.) Deposits Extent:  
Infiltration: **None** Pipe Seal Cond: **Sound**
